UNIVERSITY of
TASMANIA

Sandy Bay building condition and functionality report

> July 2018

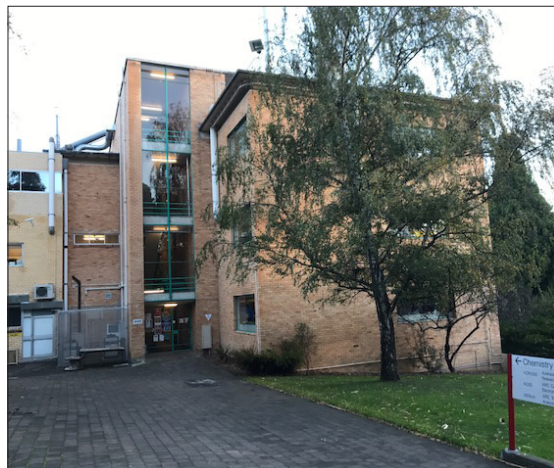
Condition Rating	Good (3.38)
Functionality Rating	Poor (2.30)
Strategic Importance	High (3.71)

- Chemistry has undertaken a range of refurbishments over the past decade, which is reflected in the 'Good' condition ratings of many of the office and lecture theatre spaces.

- Currently there is not enough room for each graduate student to have a desk and computer. Student rooms are also mixed in with labs, storage rooms and teaching spaces.

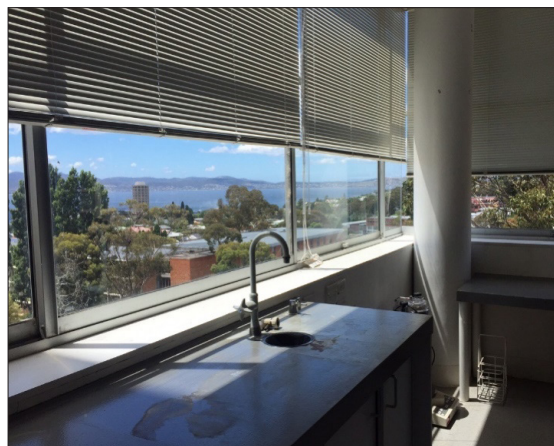
Life Sciences

Condition Rating	Fair (2.54)
Functionality Rating	Poor (2.40)
Strategic Importance	High (3.62)

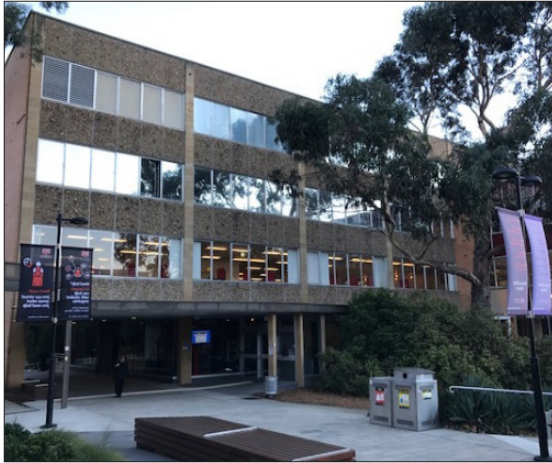
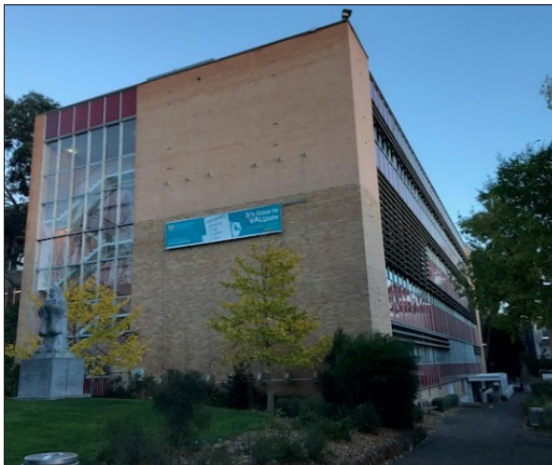
Condition Rating	Poor (2.33)
Functionality Rating	Fair (2.90)
Strategic Importance	High (3.56)

- With more than 1 million visits a year, the library is a congested space. The poor building design means that it is often over-crowded and smelly.
- Toilet facilities at the library are inadequate for the amount of use they get. They are also non-compliant with current building code requirements.

- There is inadequate space to co-locate student services and library functions together in a meaningful way.
- The building has no room for much-needed high-tech group study areas and state of the art teaching spaces. There's also no room for events or gallery spaces.

- The substructure of the library is in good condition, and the building facade has architectural merit and is valued for its "gravitas".
- Students value the central location of the library, close to the café and campus colleges.

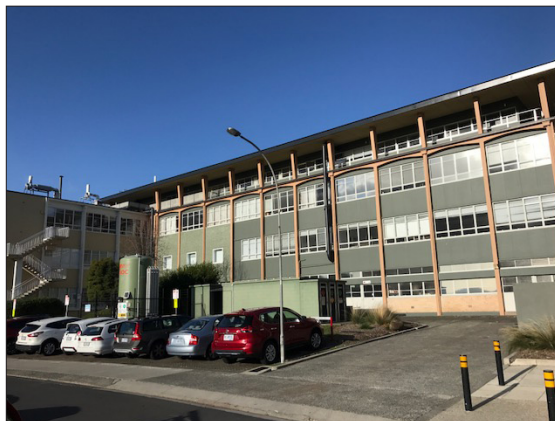
Condition Rating	Poor (2.13)
Functionality Rating	Poor (2.40)
Strategic Importance	High (3.21)

- The building has a large structural crack in the fourth-floor foyer and a leaking roof that needs replacing.
- Many windows are stuck and cannot be opened.
- The building systems are in a generally poor state and require significant replacement.
- There is a lack of air conditioning in some rooms and the noise of systems in other rooms makes the rooms unusable.
- The building has an unstable power supply and a lack of power boards which makes it difficult or impossible to install new equipment.
- There are inadequate internet connections in the building.
- Audio-visual equipment for teleconferencing is poor and staff presently have to bring their own laptops.
- There no lecture capture facilities to cater for distance students.
- Many fixtures and fittings are dated, broken and need replacing, including blinds, seats in the main lecture theatre and toilet facilities.

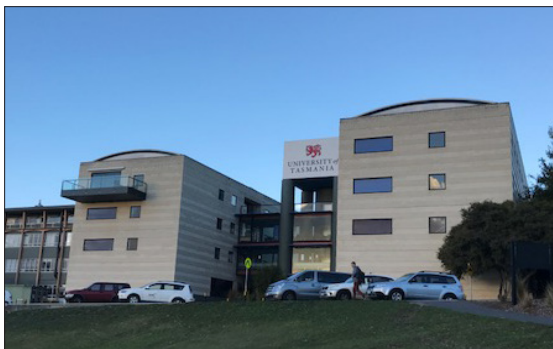
Condition Rating	Good (3.04)
Functionality Rating	Good (3.16)
Strategic Importance	High (3.05)

- The Centenary building is in good condition and is also functionally well aligned to current learning and working environments.
- It had a recent refurbishment to accommodate TSBE and dedicated Harvard-style lecture theatres.

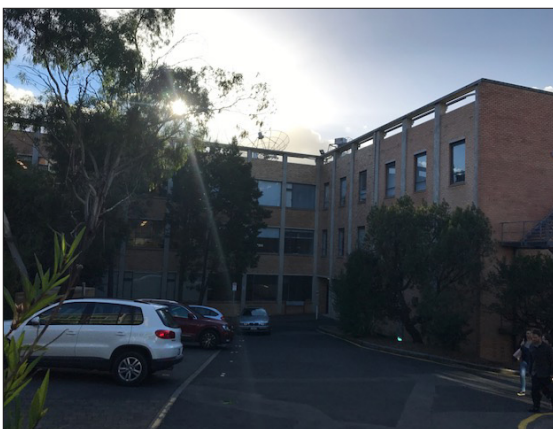
Condition Rating	Fair (2.57)
Functionality Rating	Poor (2.40)
Strategic Importance	Moderate (2.40)

- The Physics building houses small discrete offices that are poorly lit and discourage collaboration.
- There is limited space for staff and students to meet and collaborate.
- Significant investment is required to address a lack of air conditioning, technology, basic amenities and a poor state of fixtures and fittings.

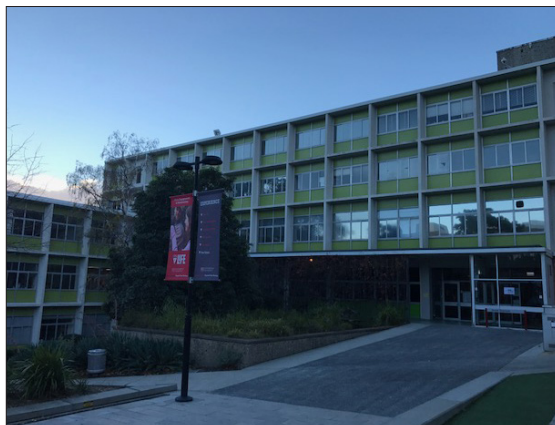
Condition Rating	Poor (2.44)
Functionality Rating	Poor (2.50)
Strategic Importance	High (3.14)

- The Psychology and Social Sciences building is in poor condition and also rates poorly for functionality.
- The separate offices are appreciated by academics, with enjoyable vistas, but the general condition of facilities is poor.
- There is a lack of professional meeting rooms and collegial communal spaces.
- There are significant temperature control issues in the building in both winter and summer, with staff sent home on numerous occasions due to untenable conditions.
- Internet connections and power supplies are insufficient for modern requirements.
- Basic services such as elevators and restrooms require significant replacement.
- There are also many accessibility issues which would require a costly retrofit.

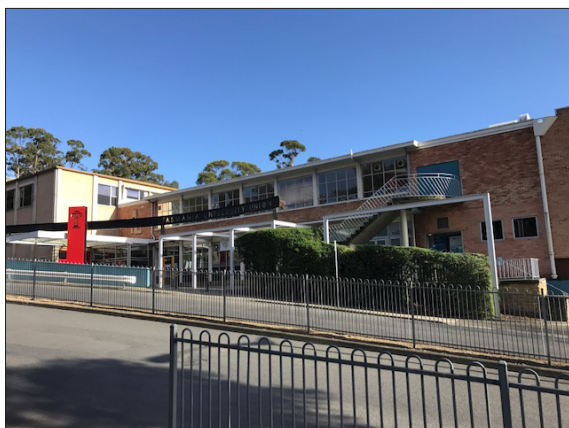
Condition Rating	Very Poor (1.74)
Functionality Rating	Fair (2.81)
Strategic Importance	Moderate (2.25)

The TUU Building has one of the lowest overall condition ratings across the Sandy Bay campus, 56% below the Council target of 4. It has significant accessibility and building compliance issues.

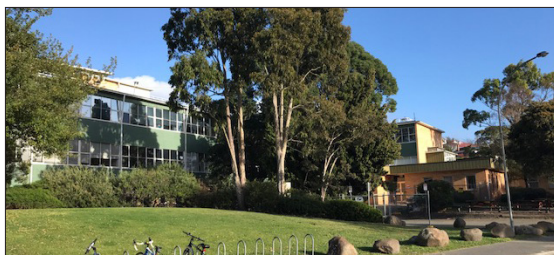
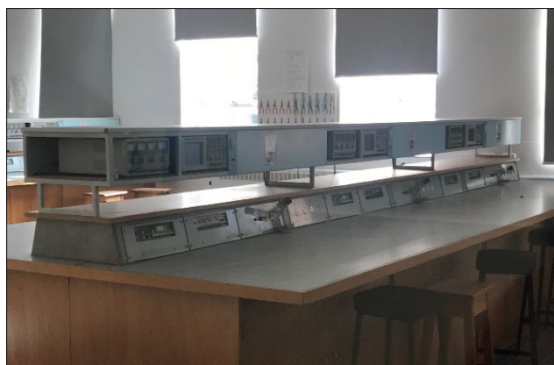
Condition Rating	Fair (2.88)
Functionality Rating	Poor (2.30)
Strategic Importance	High (3.70)

- The Engineering and Spatial Sciences Building is set up in a way typical of the era it was built – 1958.
- It has long corridors with closed offices which discourage collaboration and collegiality.
- Being set apart from other science buildings doesn't help create connections between staff and students from other science disciplines.
- Many of the workshops and labs require significant upgrading and are below the standard of current high school facilities.
- Rating was assessed as "Fair" before extensive flood damage. Since the flooding, activities have been relocated elsewhere on campus as the spaces are generally not being refurbished.

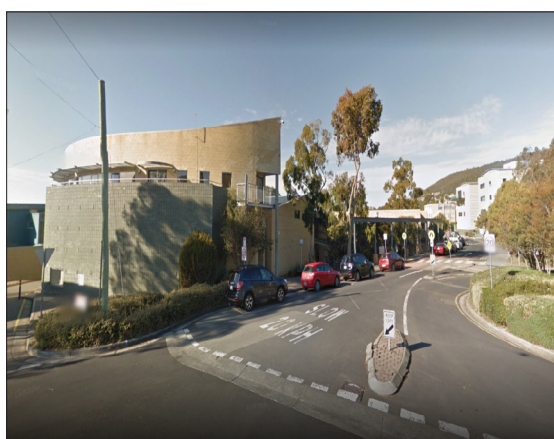
Condition Rating	Good (3.22)
Functionality Rating	Good (3.23)
Strategic Importance	High (3.13)

- The condition of the Law Building was assessed before it was damaged by flooding.
- The Law library is well regarded and utilized as a student study area with adequate office and teaching spaces.
- Prior to flooding, the building had normal levels of wear and tear.
- Refurbishment of the building since the flooding includes internal finishes, fabrics, recarpeting, repainting, and the instalment of an additional data node.

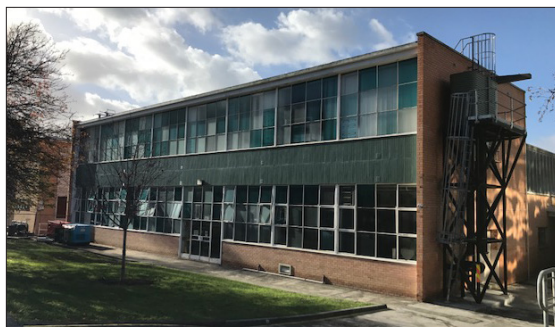
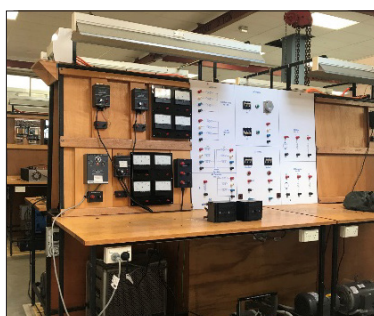
Year constructed	1960 (58 years old)
Gross floor area	3,631 m ²

Condition Rating	Poor (2.59)
Functionality Rating	Poor (2.35)
Strategic Importance	High (3.26)

The Engineering Workshop contains research and teaching labs, workshops, academic offices for engineering staff, a breakout space and a conference/tea room area.

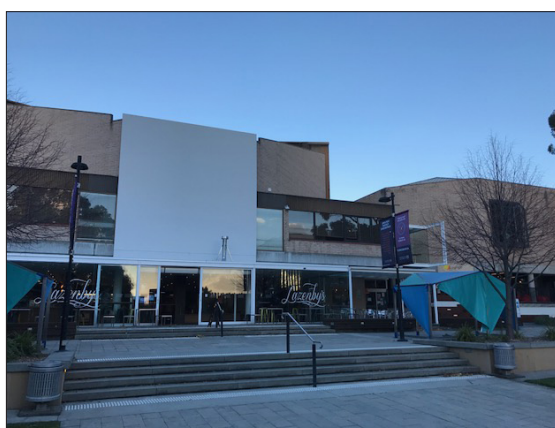
Year constructed	1976 (42 years old)
Gross floor area	3,539 m ²

Condition Rating	Very Poor (1.61)
Functionality Rating	Fair (2.70)
Strategic Importance	High (3.26)

The Stanley Burbury theatre is the largest teaching space on campus. On the lower levels there is a Museum and Student Lounge with space currently under refurbishment for the incoming GRO staff and HDR Hub. On the ground floor facing the main campus courtyard is Lazenby's café.

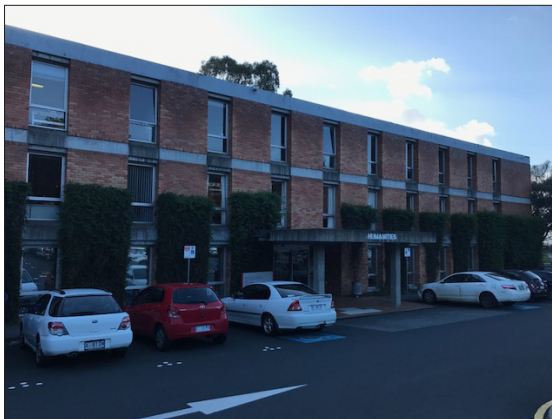
Condition Rating	Very Poor (1.66)
Functionality Rating	Fair (2.66)
Strategic Importance	High (3.15)

- Humanities has significant strategic importance to the university especially given its share of the student population.
- Currently this building is in very poor condition.
- Significant investment is required to address a lack of air conditioning, technology, basic amenities and a poor state of fixtures and fittings.
- The building has very poor disabled access and very limited wheelchair access. There is no lift for wheelchair access and no disabled toilet.
- There is a lack of small and large meeting rooms for small staff seminars.
- There is also a lack of appropriate communal space for postgraduates.

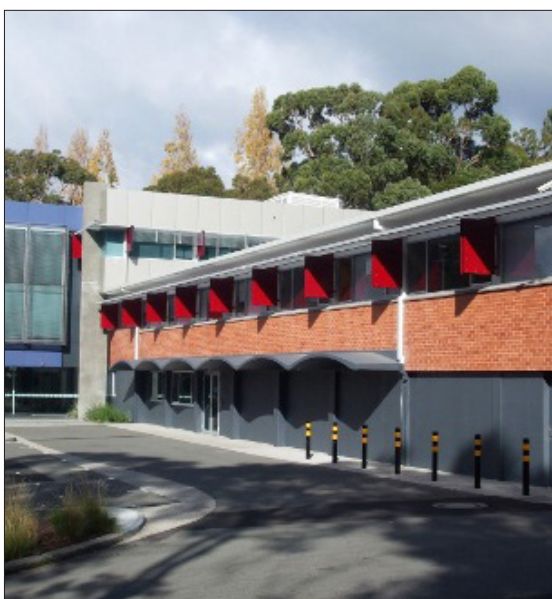
Condition Rating	Good (3.88)
Functionality Rating	Good (3.45)
Strategic Importance	Moderate (2.71)

- Despite the impact of flooding in May 2018, the corporate services building has had significant refurbishment and is in good condition.
- The building has a generally good spatial layout for professional services staff with a mix of offices, open plan areas and meeting rooms.

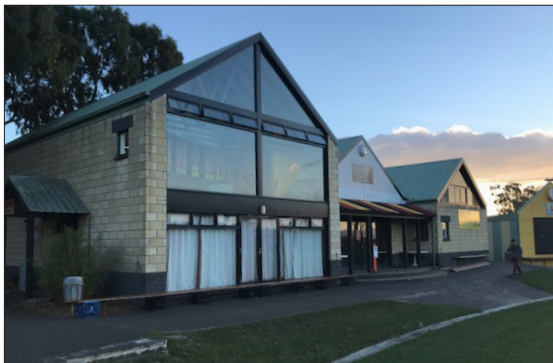
Condition Rating	Good (3.70)
Functionality Rating	Good (3.82)
Strategic Importance	Moderate (2.34)

- The gym suffered some damage from the flooding in May 2018, which has been repaired.
- The building is otherwise in good condition following regular refurbishment.

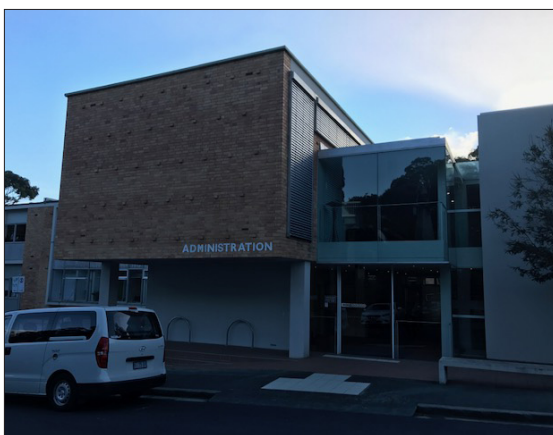
Year constructed	1970 (48 years old)
Gross floor area	2,386 m ²

Condition Rating	Good (3.56)
Functionality Rating	Good (3.58)
Strategic Importance	High (3.01)

The Administration building provides accommodation for the Chancellery, Vice Chancellor and VC Office, DVC Research, Global, COO office, Governance, Audit and Risk, Marketing and Strategy.

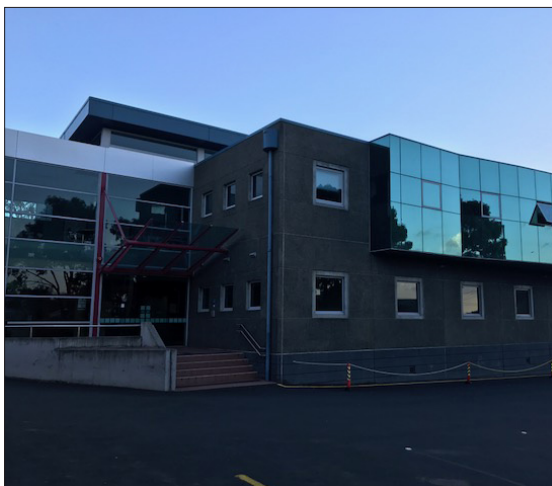
Condition Rating	Good (3.94)
Functionality Rating	Good (3.23)
Strategic Importance	High (3.19)

- The Old IMAS building is the newest facility on the Sandy Bay campus.
- The good structural and functional condition of the facility enables flexibility in alterations to the internal fit-out and services.
- The building is currently being re-purposed for the Faculty of Education and University College.

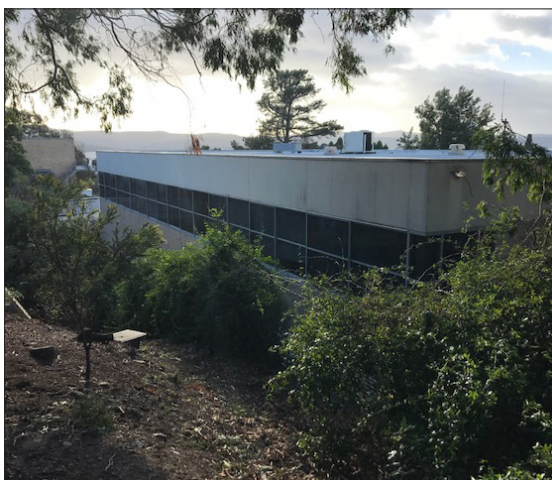
Condition Rating	Poor (2.36)
Functionality Rating	Fair (2.60)
Strategic Importance	High (2.62)

- The Psychology Research Centre is in poor condition with a functionality rating at the lower end of the 'fair' spectrum.

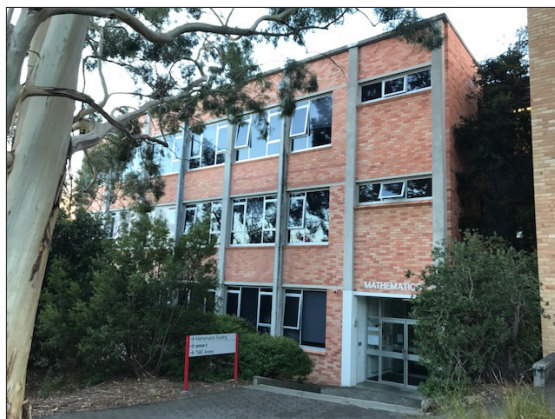
Condition Rating	Poor (2.24)
Functionality Rating	Poor (2.50)
Strategic Importance	Moderate (2.31)

- The Mathematics building houses small discrete offices that are poorly lit and discourage collaboration.
- It has long corridors and a lack of suitable spaces for staff and students to meet and study together.
- In addition to a poor condition and functionality assessment, the building requires significant accessibility and building code compliance work.
- More recently, staff space has been redeveloped on level 1.

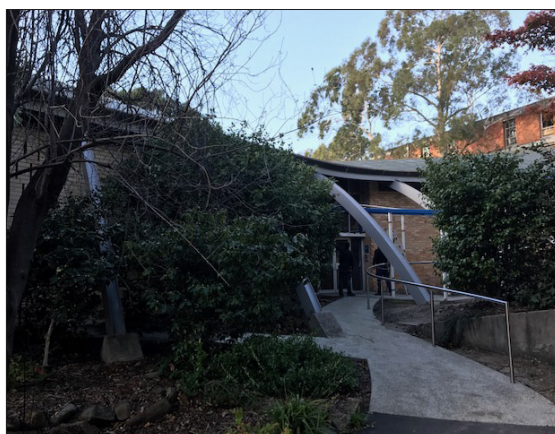
Condition Rating	Poor (2.95)
Functionality Rating	Fair (3.15)
Strategic Importance	High (2.96)

- As the Arts Lecture theatre is heritage listed, the University has a duty to ensure preventative maintenance is undertaken to improve its current poor condition rating.
